PUBLIC WORKS CENTER PEARL HARBOR FLEET MOORINGS UNDERWATER INSPECTION REPORT

SEPTEMBER 1983

OCEAN ENGINEERING
AND CONSTRUCTION PROJECT OFFICE
CHESAPEAKE DIVISION
NAVAL FACILITIES ENGINEERING COMMAND
WASHINGTON, D.C. 20374

FPO-1-83(22)

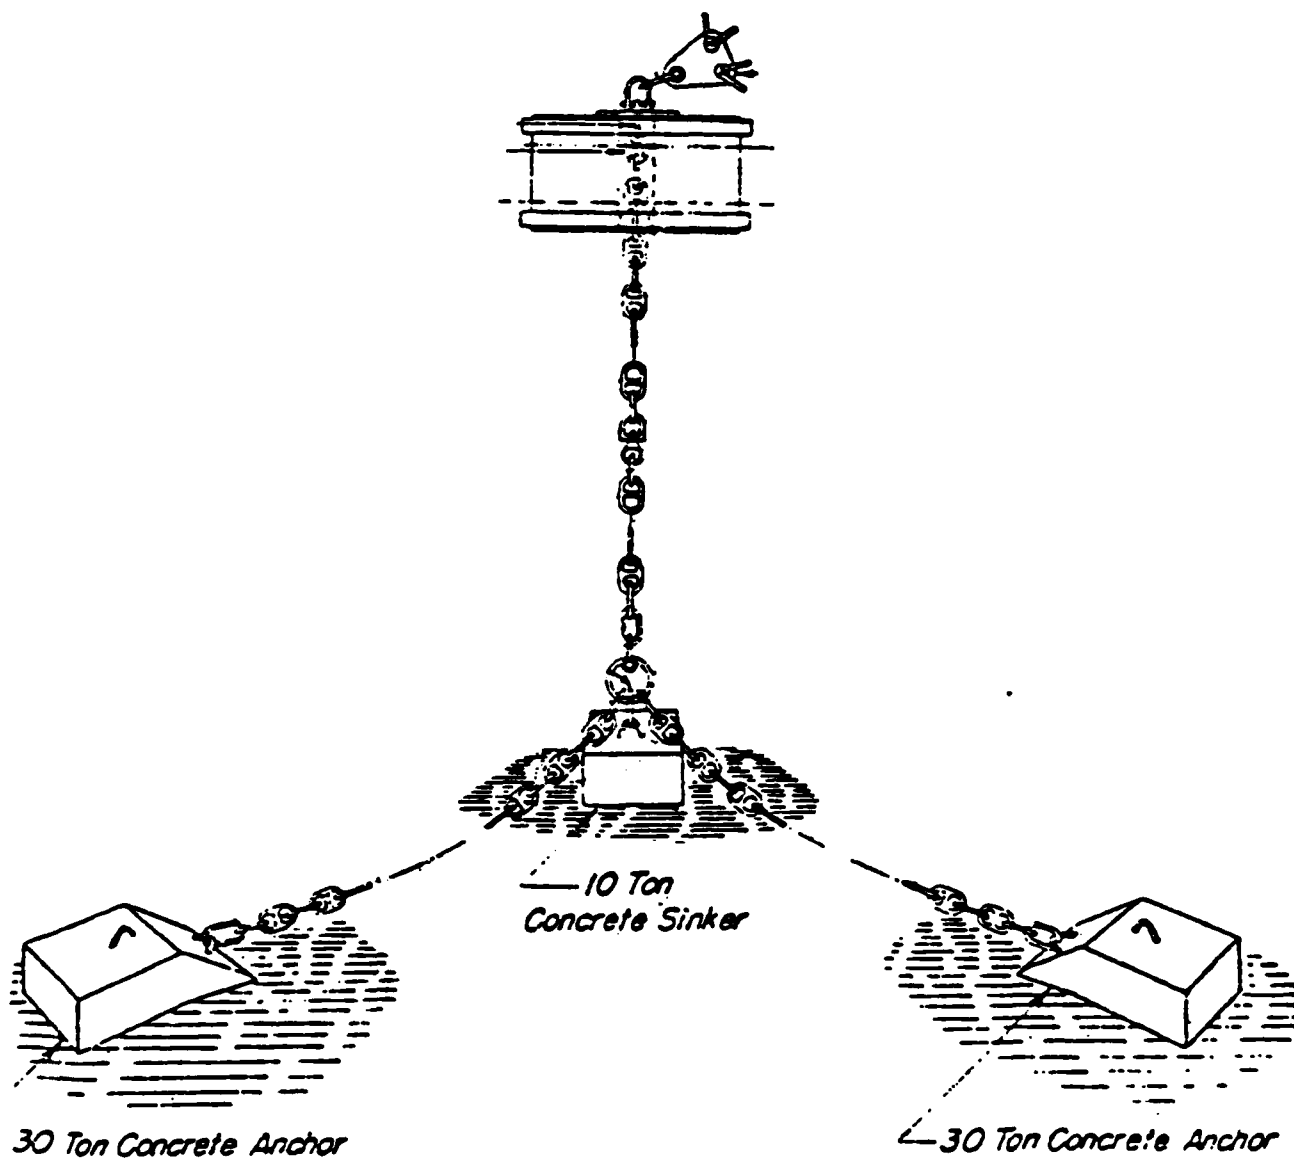
**MOORING AM13
SCHEMATIC DRAWING**

This is a 12-foot-diameter drum-type buoy with 6-foot-high side plating. The top and bottom fenders and the chafing rail are made of timber and are all in good condition. The buoy has a hawsepipe through which passes 2 3/4-inch riser chain. The top of the buoy is moderately rusted, and the buoy has a slight list which could indicate a leak in its watertight integrity.

This mooring is in unsatisfactory condition for continued fleet use because the anchors and buoy are displaced, and the ground ring measures below 80 percent of its original wire diameter. Recommend that the mooring be recovered, inspected, overhauled, and reinstalled in its proper location.

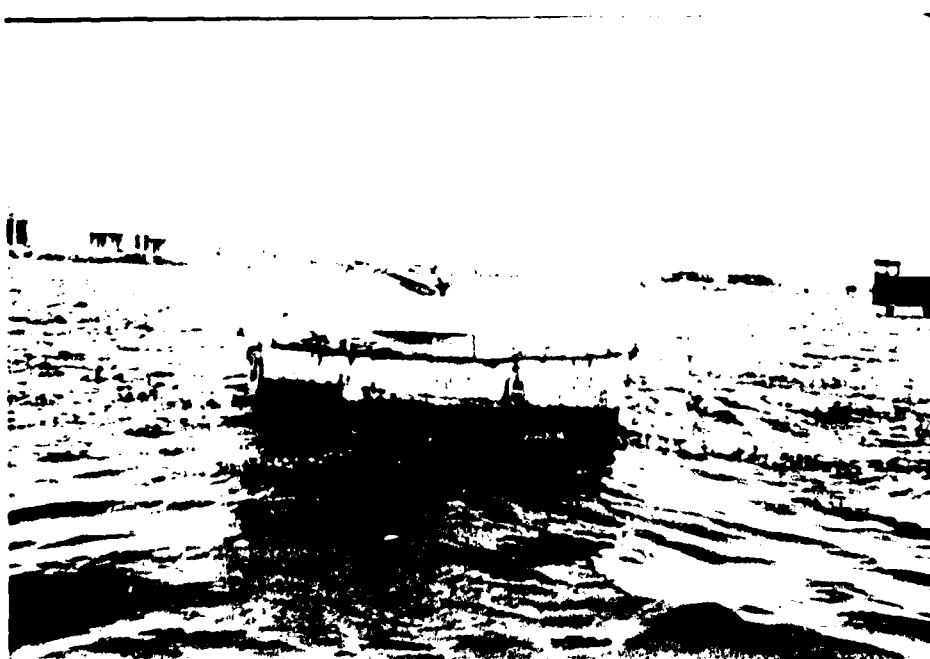
- o The fenders of five mooring buoys (AM13A, D5N, D6M/6S, D11M, and D12S) are either damaged, loose, or missing sections.

Damaged Wooden Fender of Buoy AM13A

- o The fender systems of five of the mooring buoys (AM13A, D5N, D6M/6S, D11M, and D12S) should be repaired/replaced as required.
- o Although the 21 moorings which were determined to be in fair condition should have sufficient capacity to withstand the maximum loads of their current mooring class designations, these moorings should be overhauled and upgraded as soon as feasible in order to meet the original mooring class requirements as shown in the PWC Pearl Harbor Fleet Mooring Data Sheets contained in Annex A.

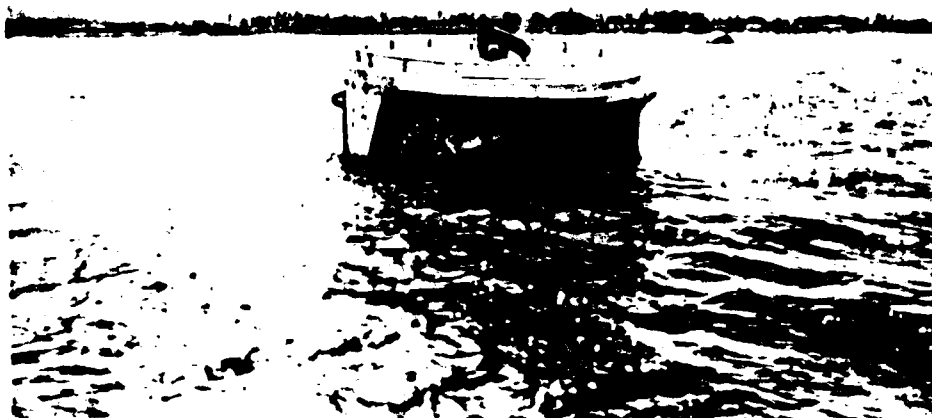
Fender Damage to Buoy D6M/6S

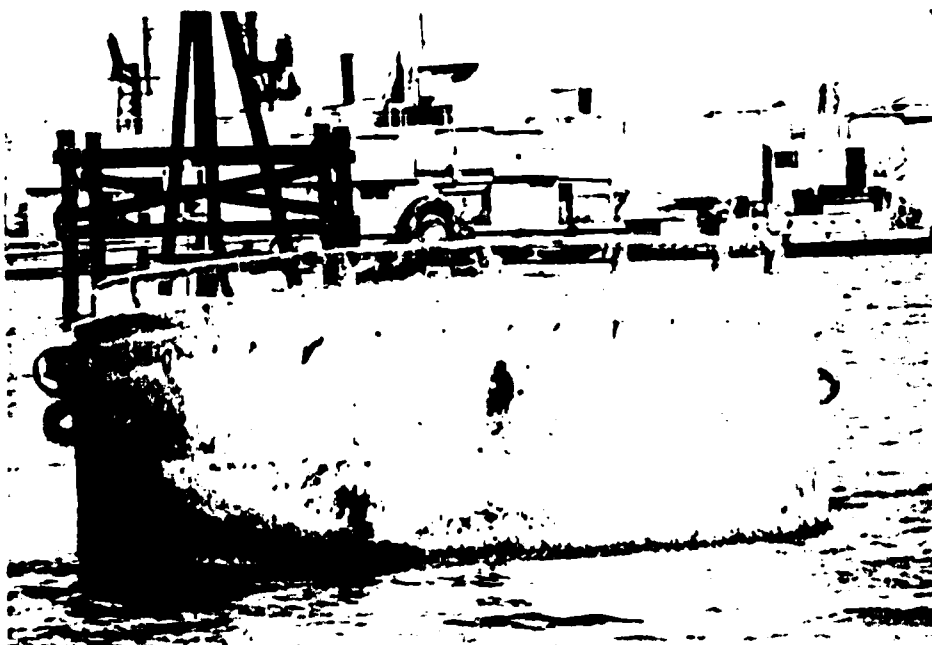
Buoy D12S With Missing Fender

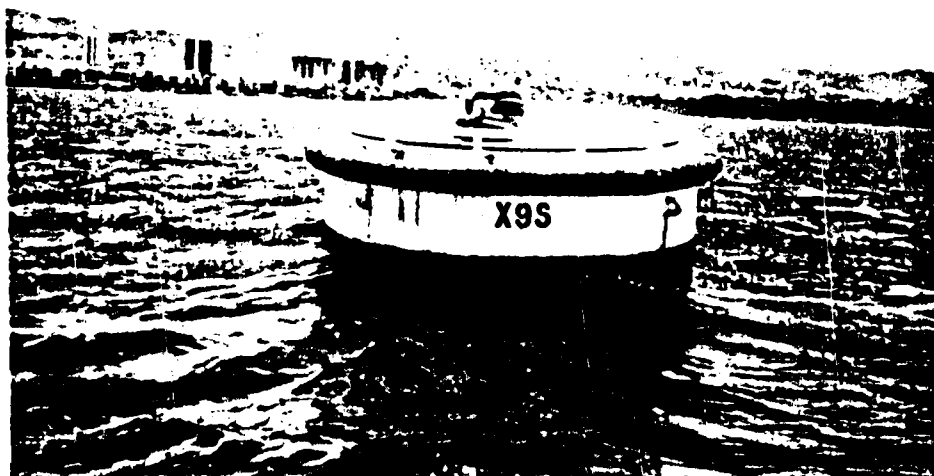
Typical Condition of Recently Overhauled Buoys
